# Manhole Inspection Summary

Manhole # S31CC2008MH

**Location** Address: **119 CHURCHWARDENS RD**

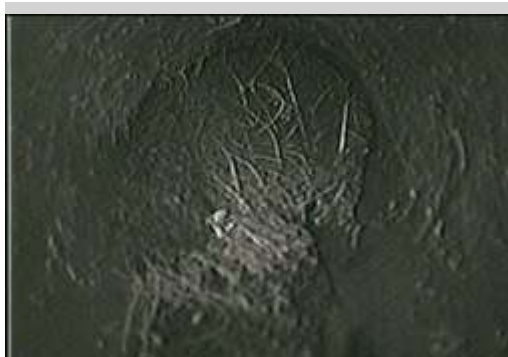
Bench and Channel debris.

Pipe I8 Root intrusion

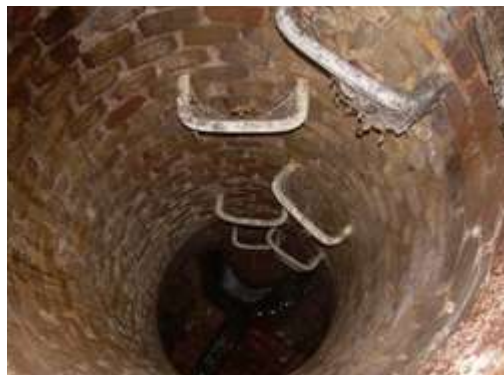
Defect

Adjustment deterioration and infiltration.  
Corbel and Barrel infiltration - other side.

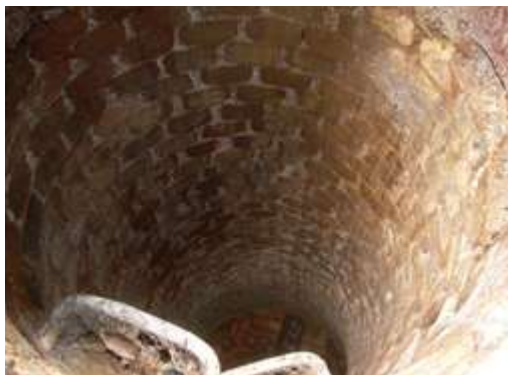
Defect

Adjustment deterioration and infiltration.  
Corbel and Barrel infiltration.

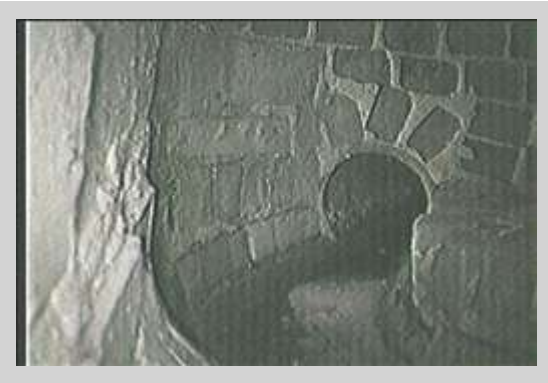
### 8 in. Circular Gravity Sewer Pipe Out @ 12 O'Clock

Channel deterioration.

Deposits: ☐ None ☐ **Mud** ☐ Sludge ☐ **Debris** ☒ **Grease**

Infiltration: **Evidence** Pipe Seal Cond: **Unknown**

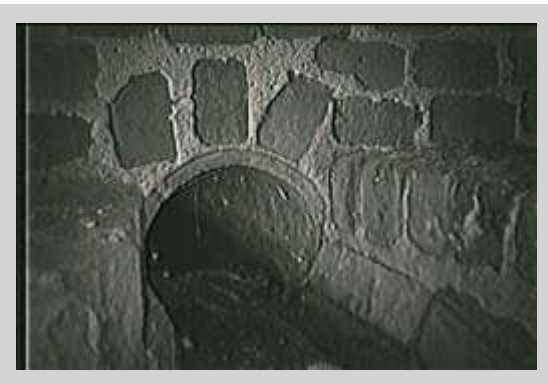
### 8 in. Circular Gravity Sewer Pipe In @ 4 O'Clock

Deposits: ☐ None ☒ **Mud** ☐ Sludge ☒ **Debris** ☐ Grease

Infiltration: **Evidence** Pipe Seal Cond: **Unknown**

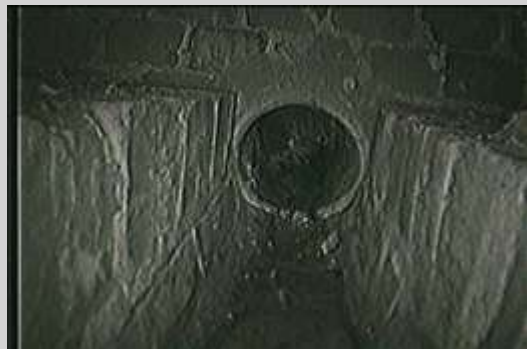
Pipe In @ 8 O'Clock

Deposits: ☐ None ☒ **Mud** ☐ Sludge ☒ **Debris** ☐ Grease
